# Sample Case : Ice-cream Factory (Compressor)

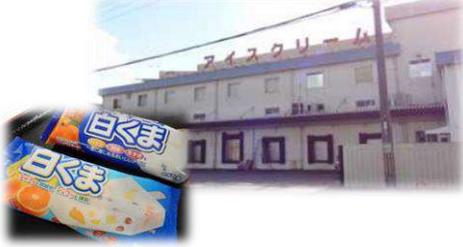
<p>Miracle Boy was installed to one of the famous ice cream factories in Japan.</p>

<p>MB (Blue Color) was connected to KOBELCO 55kw compressor.</p>

Counter Measure	Install MB to oil drain valve of the compressor.
-----------------	--

Result	<p>(1) Compressor oil cleanliness is always maintained and even cleaner than brand new oil.</p> <p>(2) <u>Before installing MB, annual overhaul cost was approx. US\$9,000~16,000, but it became ZERO</u> as clean oil is always filled with the compressor and reduce mechanical problems.</p> <p>(3) Due that the lubrication became smoother, operating load of compressor was reduced, and it leads to <u>reducing power consumption cost from US\$14,000 to ZERO.</u></p>
Voice of Customer	<p>Since we installed MB in 1994, we haven't done overhaul for more than 20years, and the compressor still running without any problem.</p> <p>MB recued large amount of costs and labor, and all we should do is exchanging filter element once in a year only.</p>
